# Dronninglund Fjernvarme

Followup meeting #8 i Aalborg, 27.10.2021

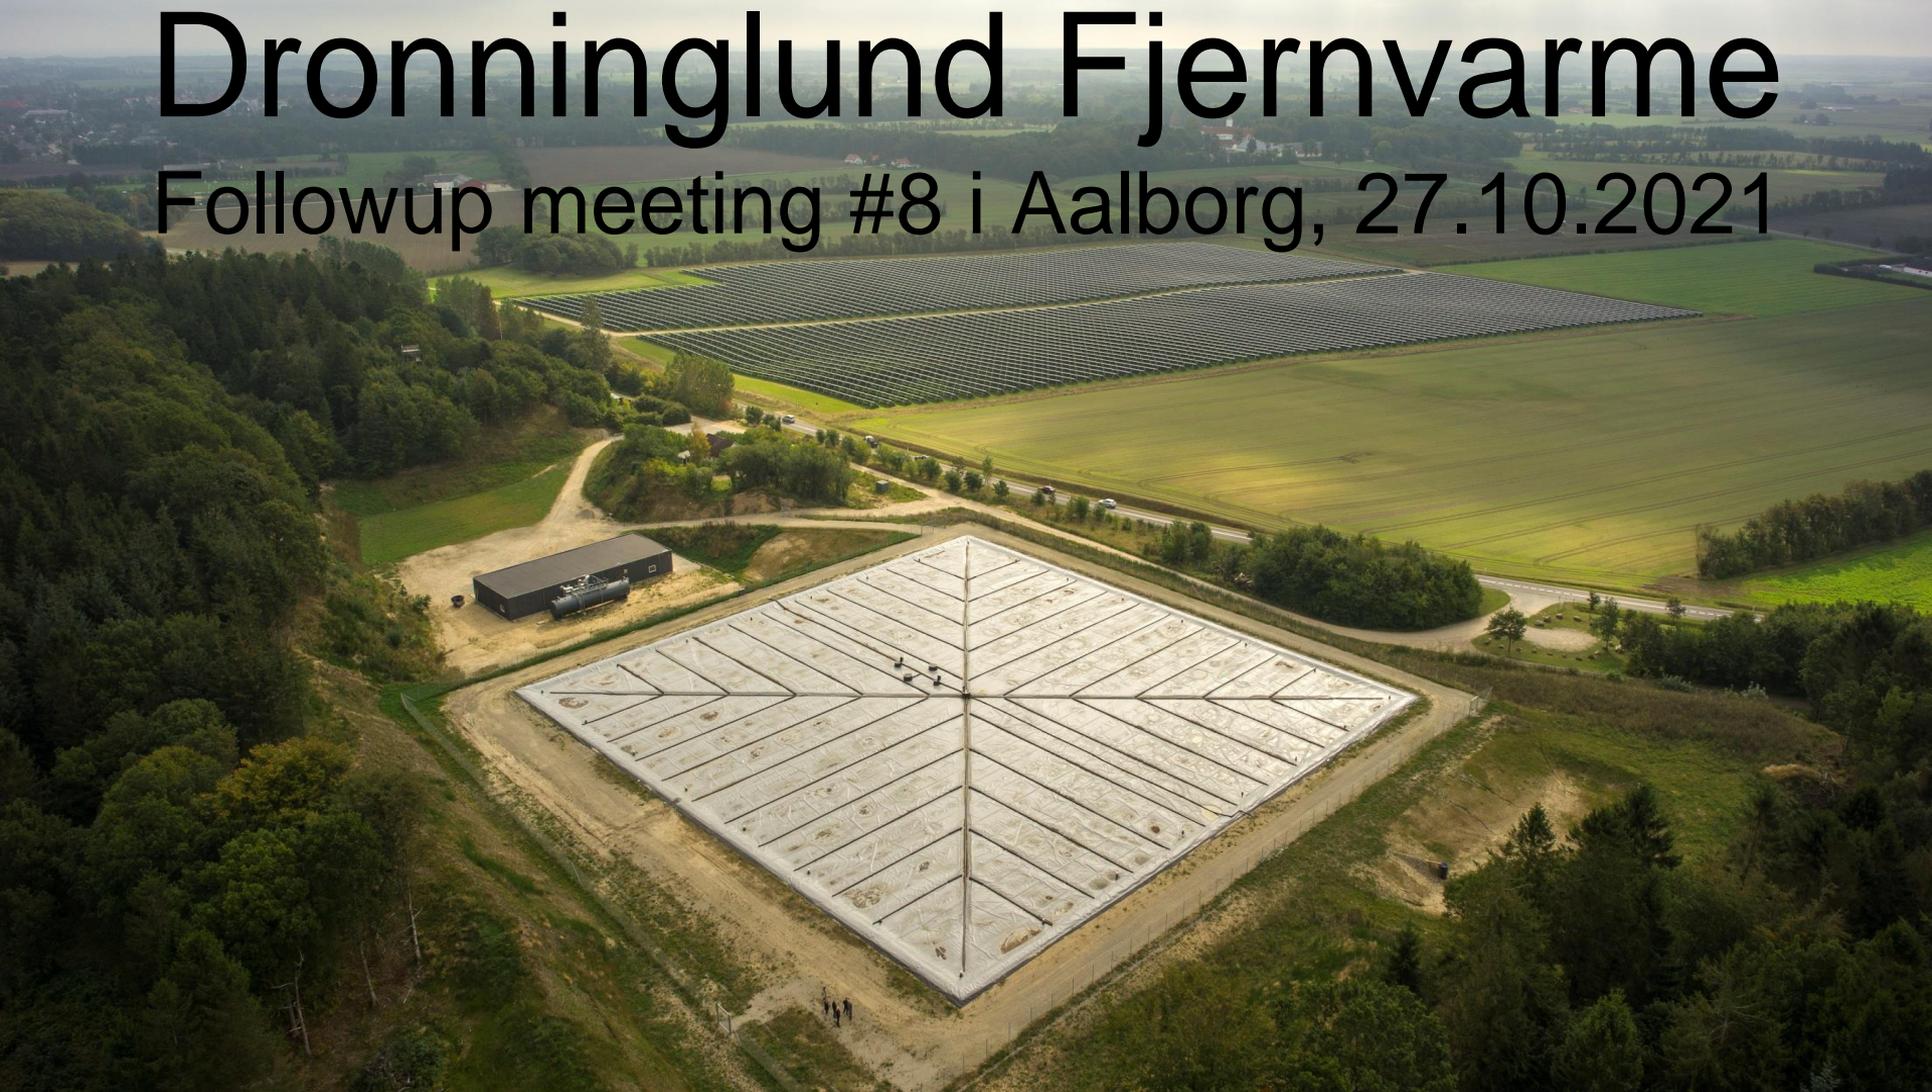
# Drone picture from an altitude of 25 meters, taken spring of 2020.

You see many small lakes forming on the top liner.  
On this picture we have started to empty the lakes in the South/ East corner

The daily maintenance consist mainly of pumping the water away from the lakes when they have grown to big.  
Time consumption app. 2-3 hours a week year around.

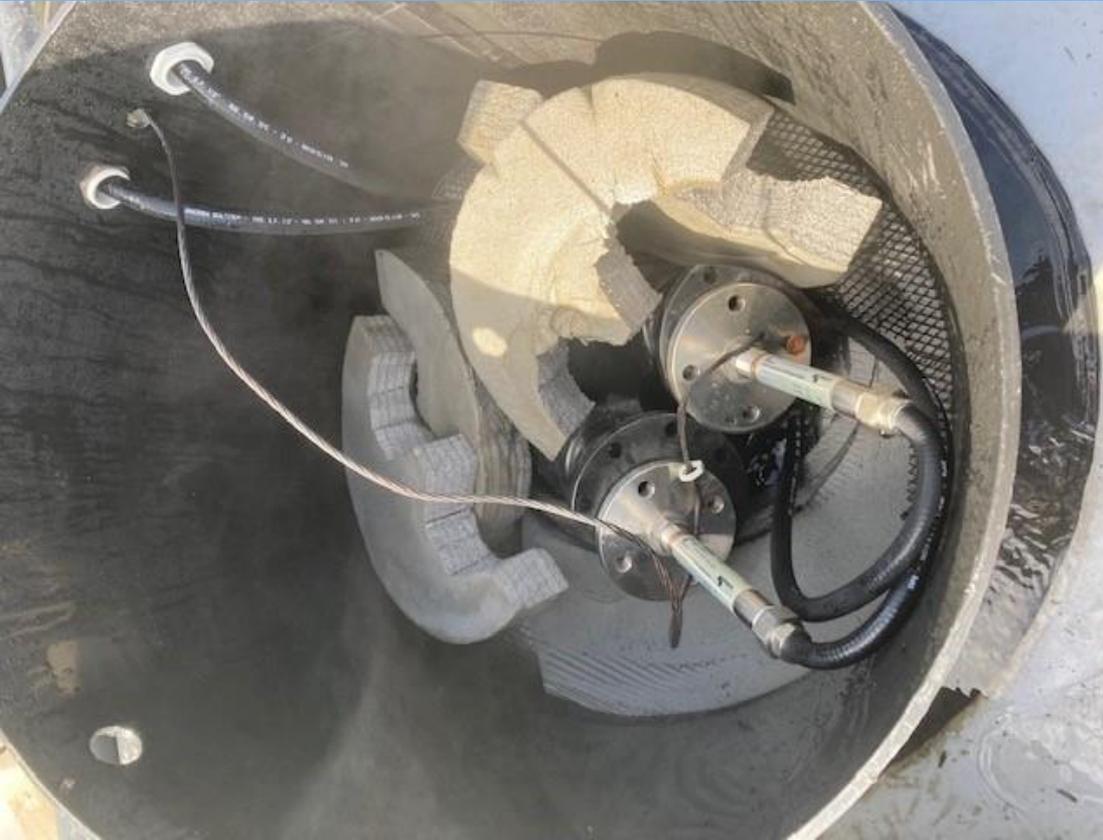
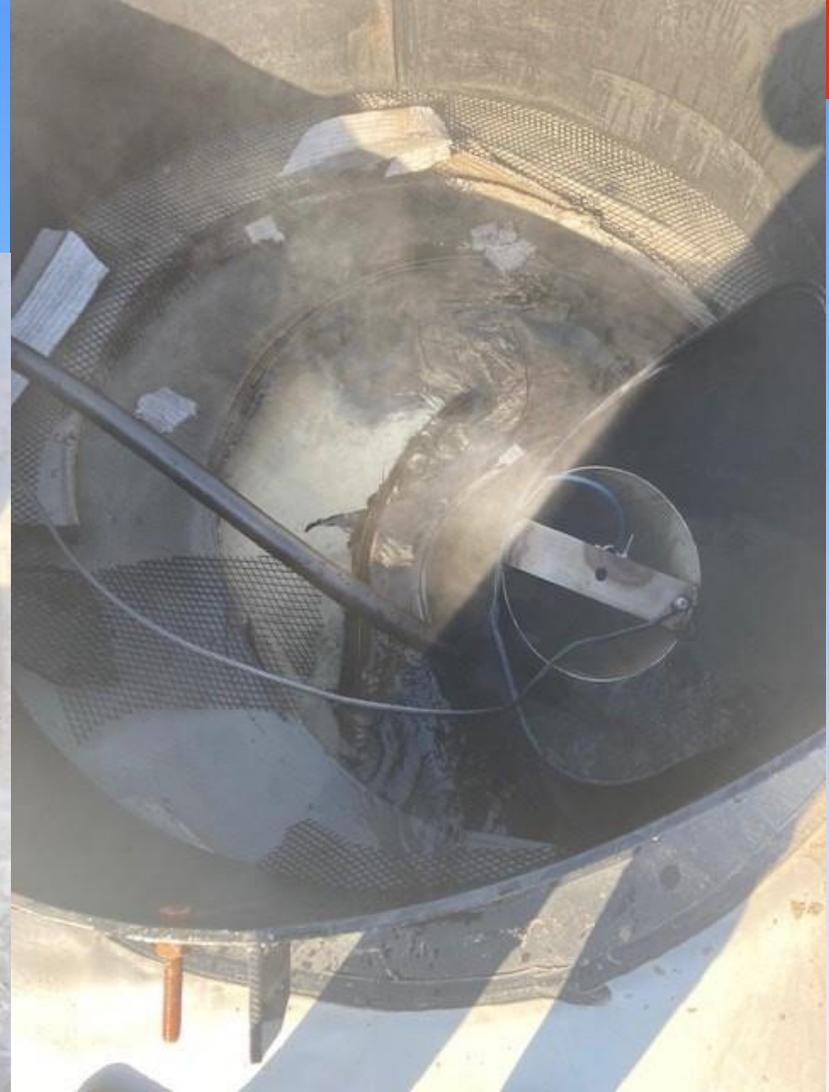
**On April 14<sup>th</sup>  
2021 we  
discovered:**

The floating liner was torn above the top inlet diffuser.  
And in other wells we could see the floating liner was pulled aside.  
After a few days the liner had sunk to a depth of app. 4 meter,

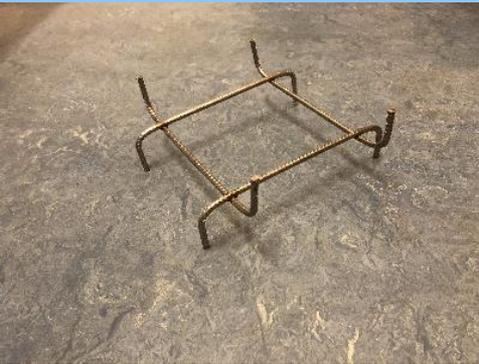
1. Top liner with weight tubes
2. Net for air circulation.
3. 3 x 8 cm isolation. Between the layers of insulation, we placed fixation irons

4. Net for air circulation.
5. Floating liner with weight tubes.

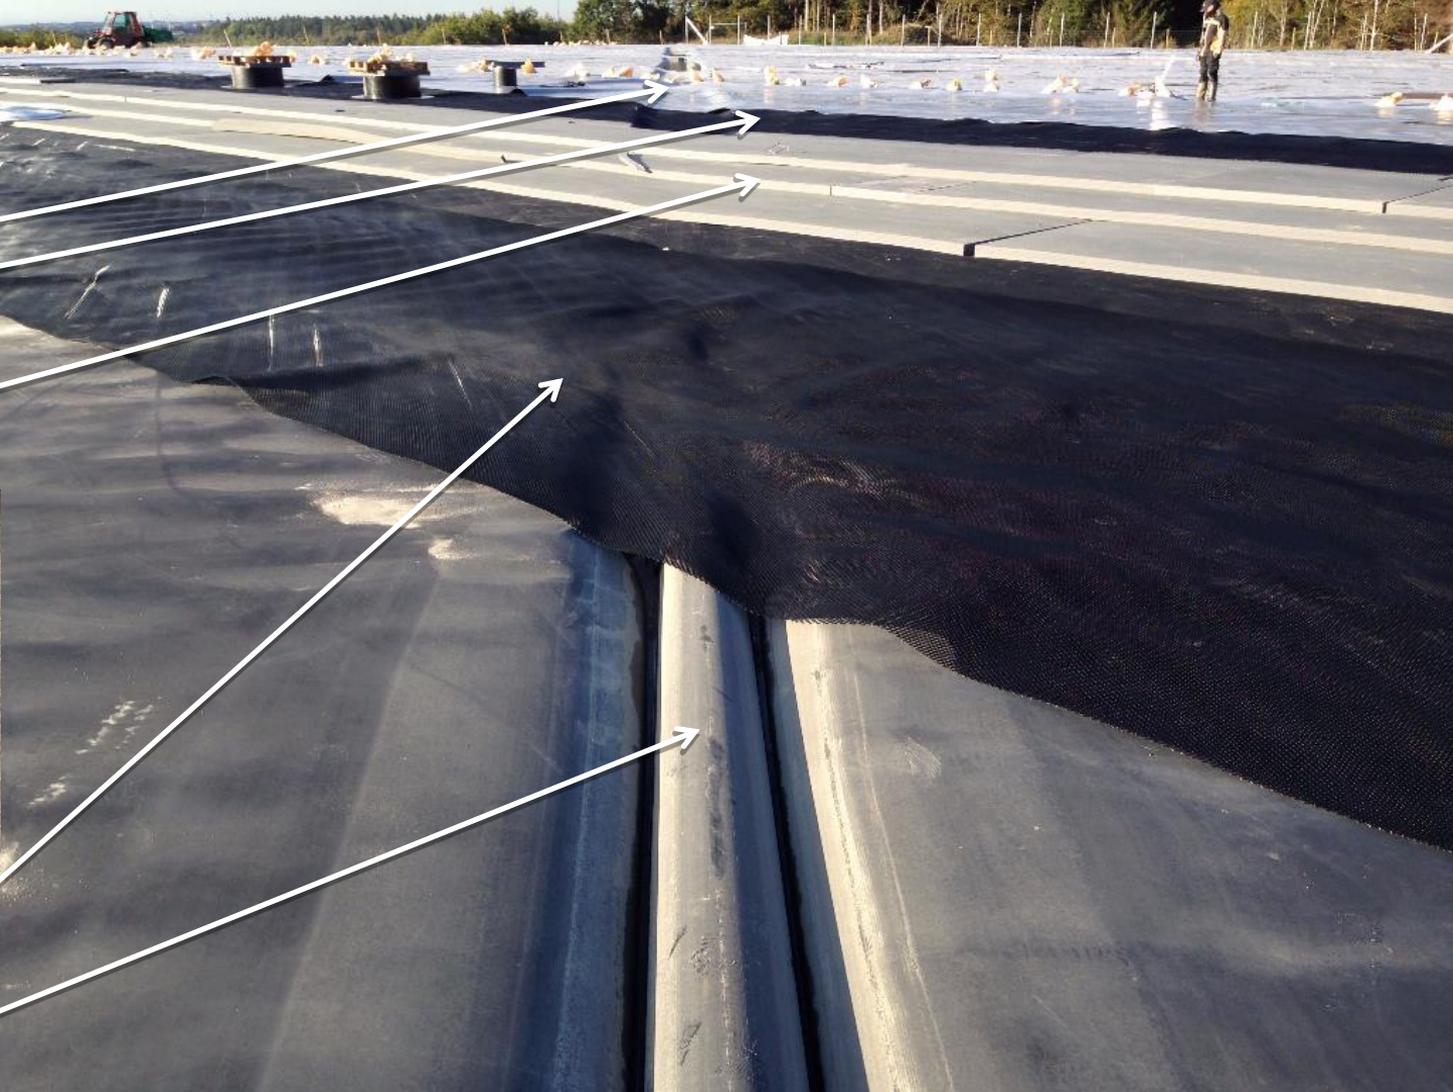
Due to holes in the floating liner hot water soaked the insulation.

As a combination of the weight from the lakes on the top liner, and the hot water, the insulation was deformed.

Some of it was reduced to  $\frac{1}{4}$  of the original thickness.

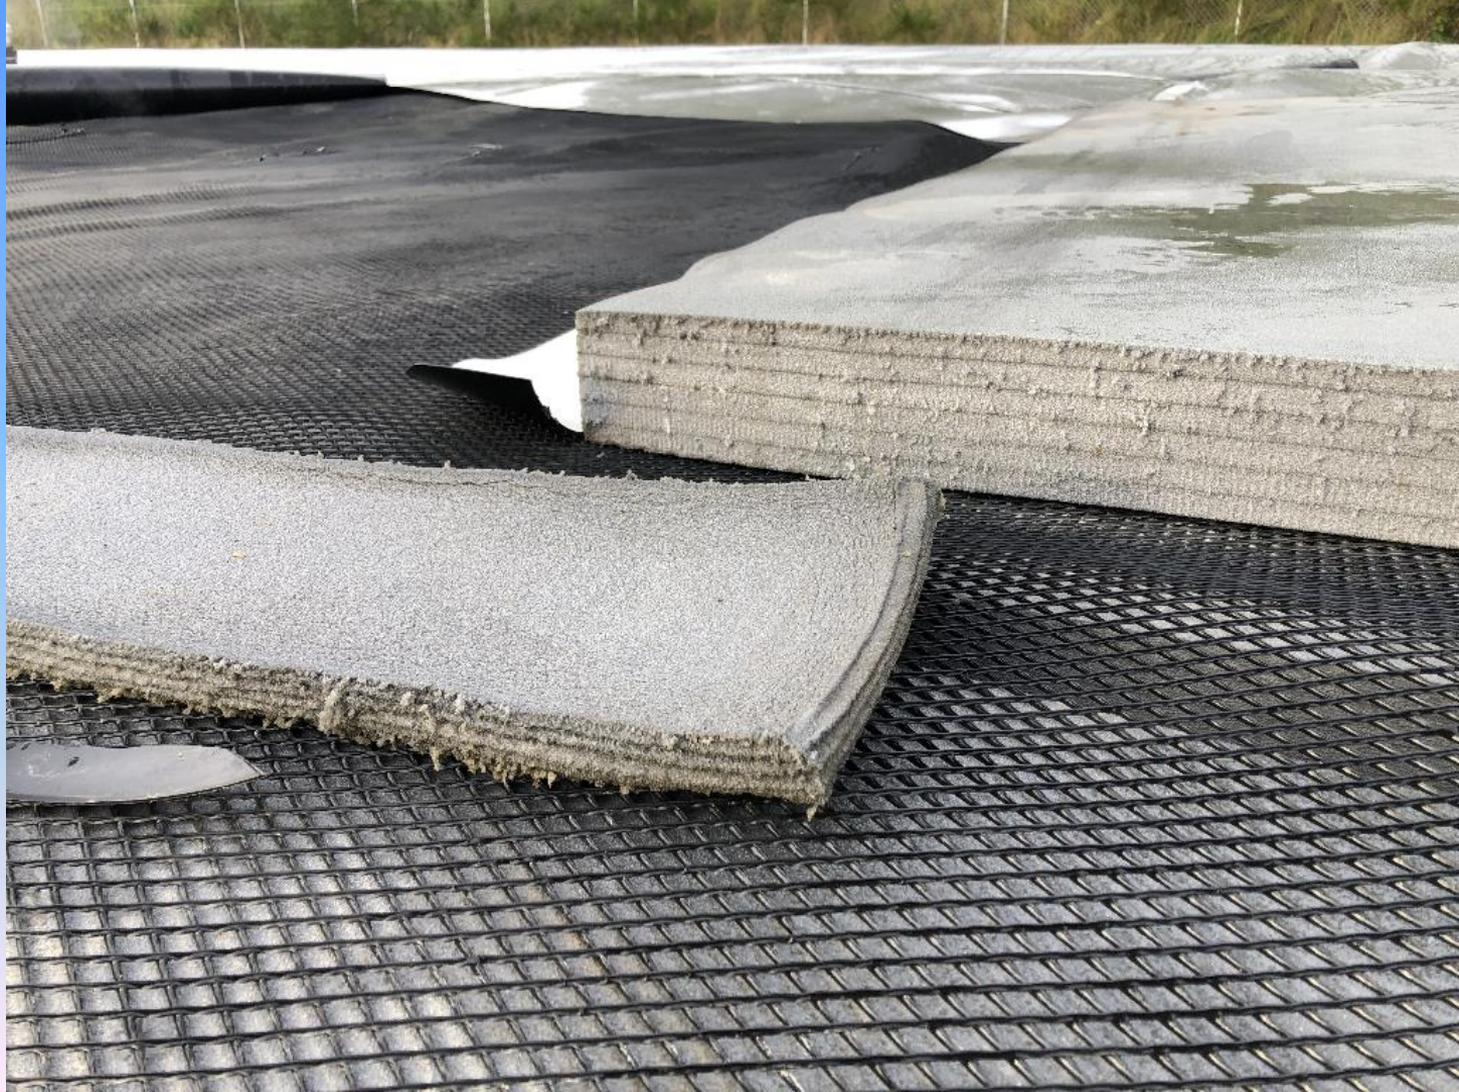
The insulation is so thin in some places, that the spikes from the fixation irons between the two lower layers is a threat to the floating liner.

That's why we begin to have holes in our floating liner.

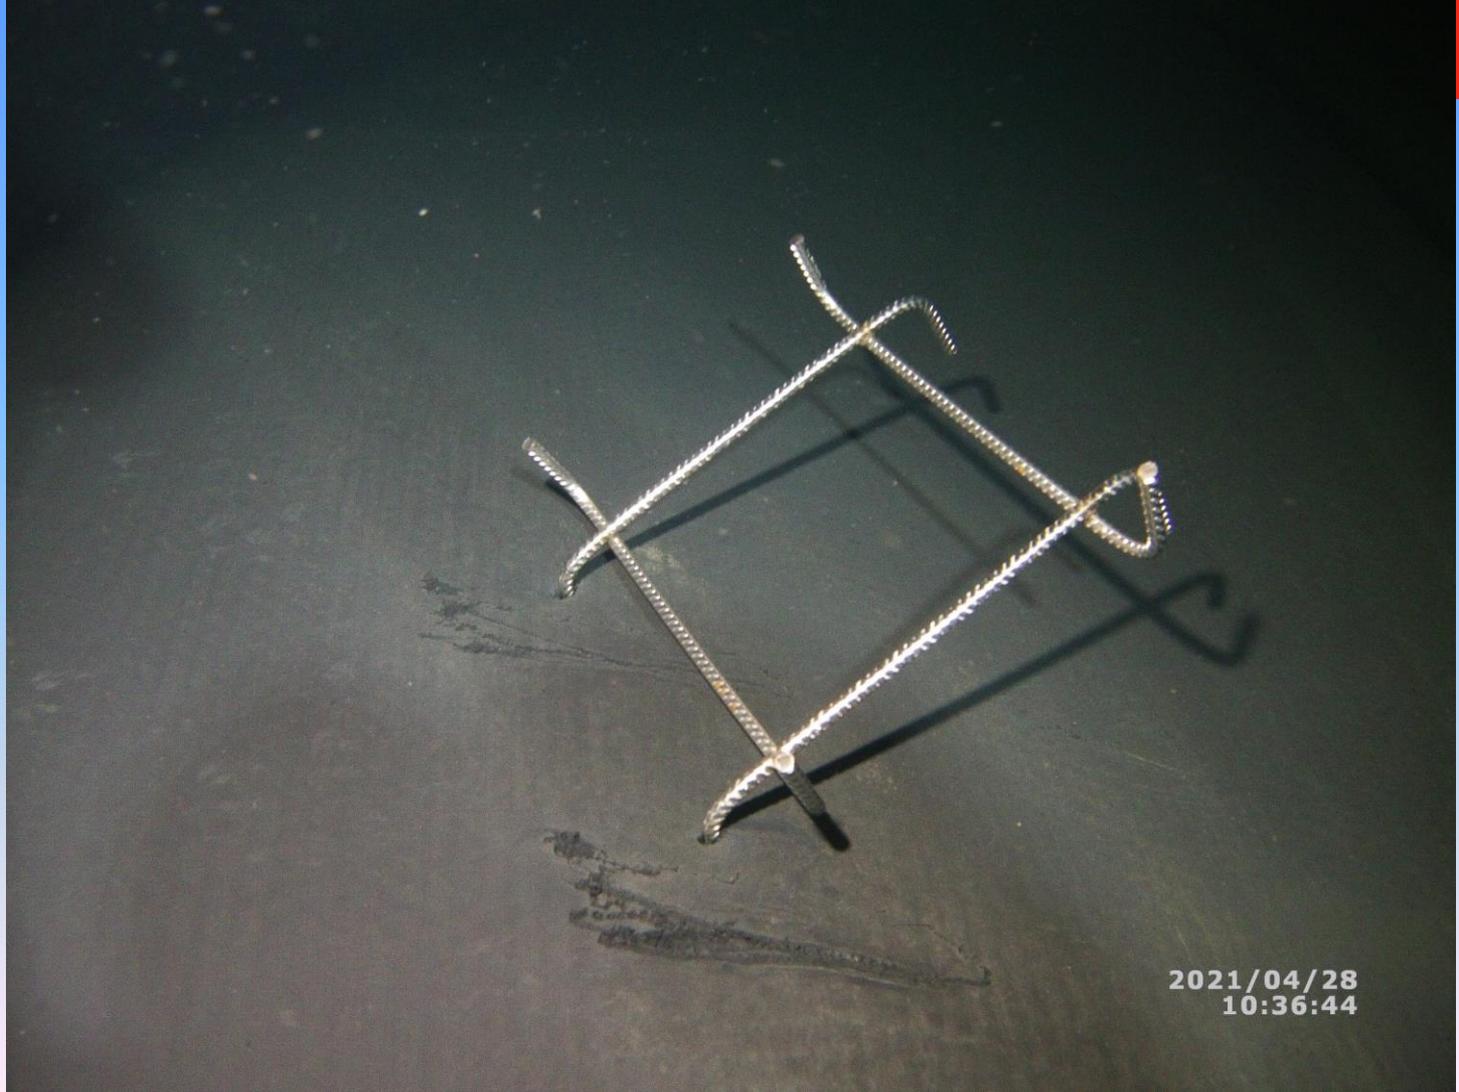
2021/04/28  
10:36:44

Another picture from the divers inspection after the floating liner has sunk app. 4,5 meter below the insulation

It shows how many fixation iron has started to penetrate the lowest layer of insulation, and thus punctuating the floating liner.

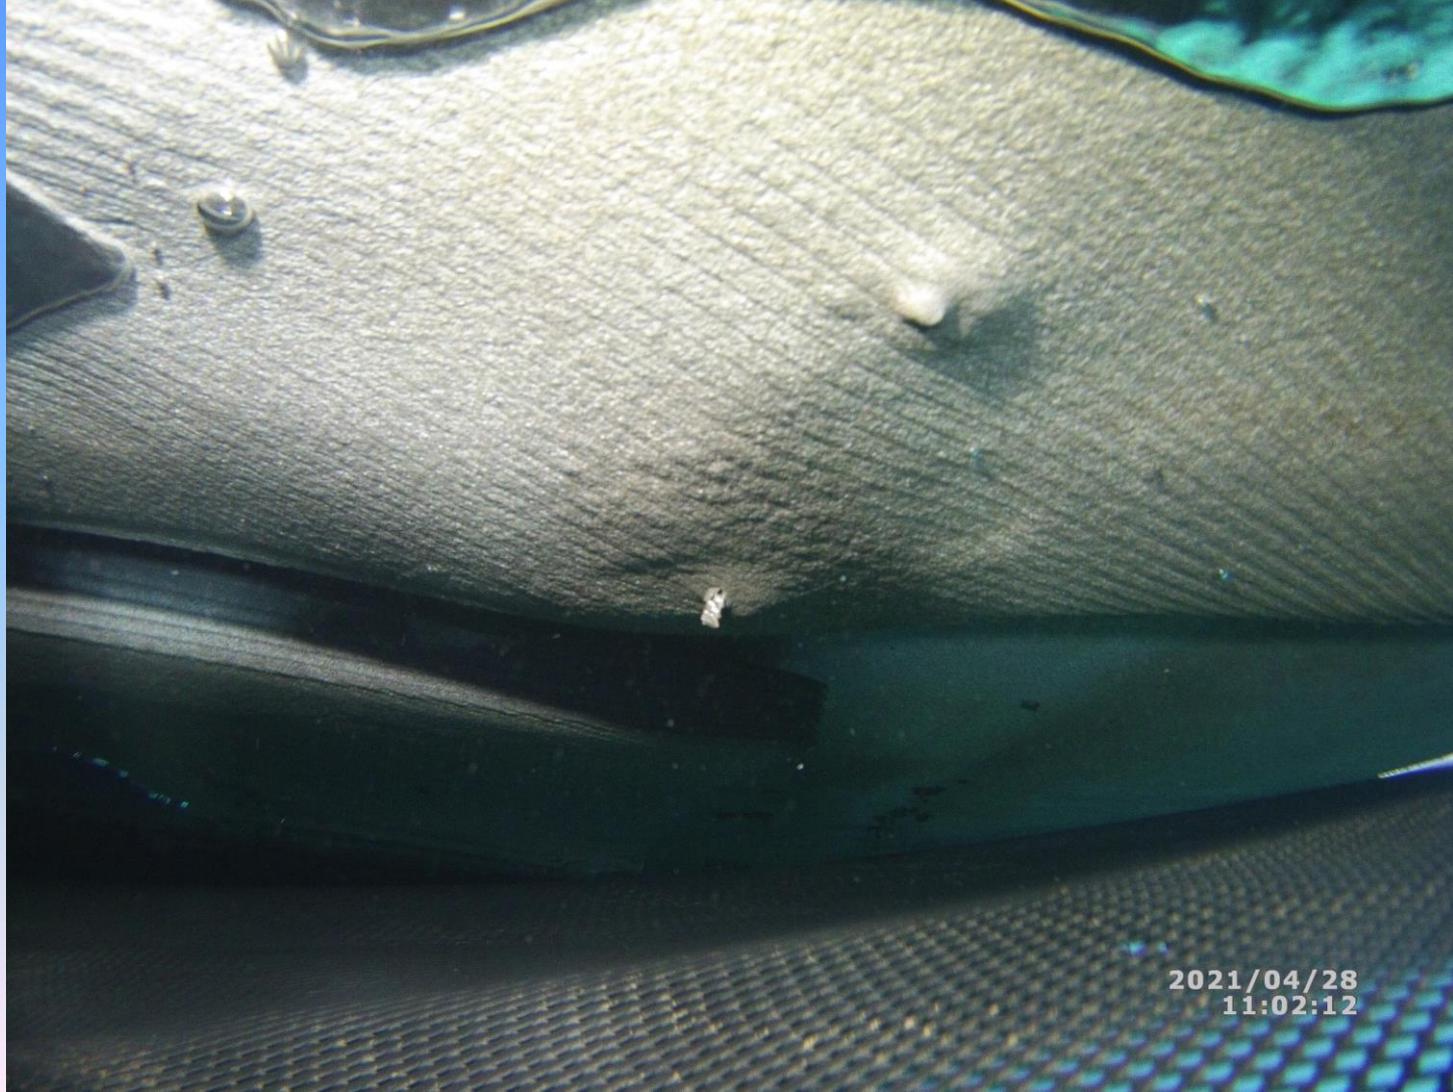
2021/04/28  
11:02:12

The top diffuser was bend  
from the weight of the sunken  
floating liner.

Eventually the edge of the top  
diffuser cut open the floating  
liner and the liner sunk.

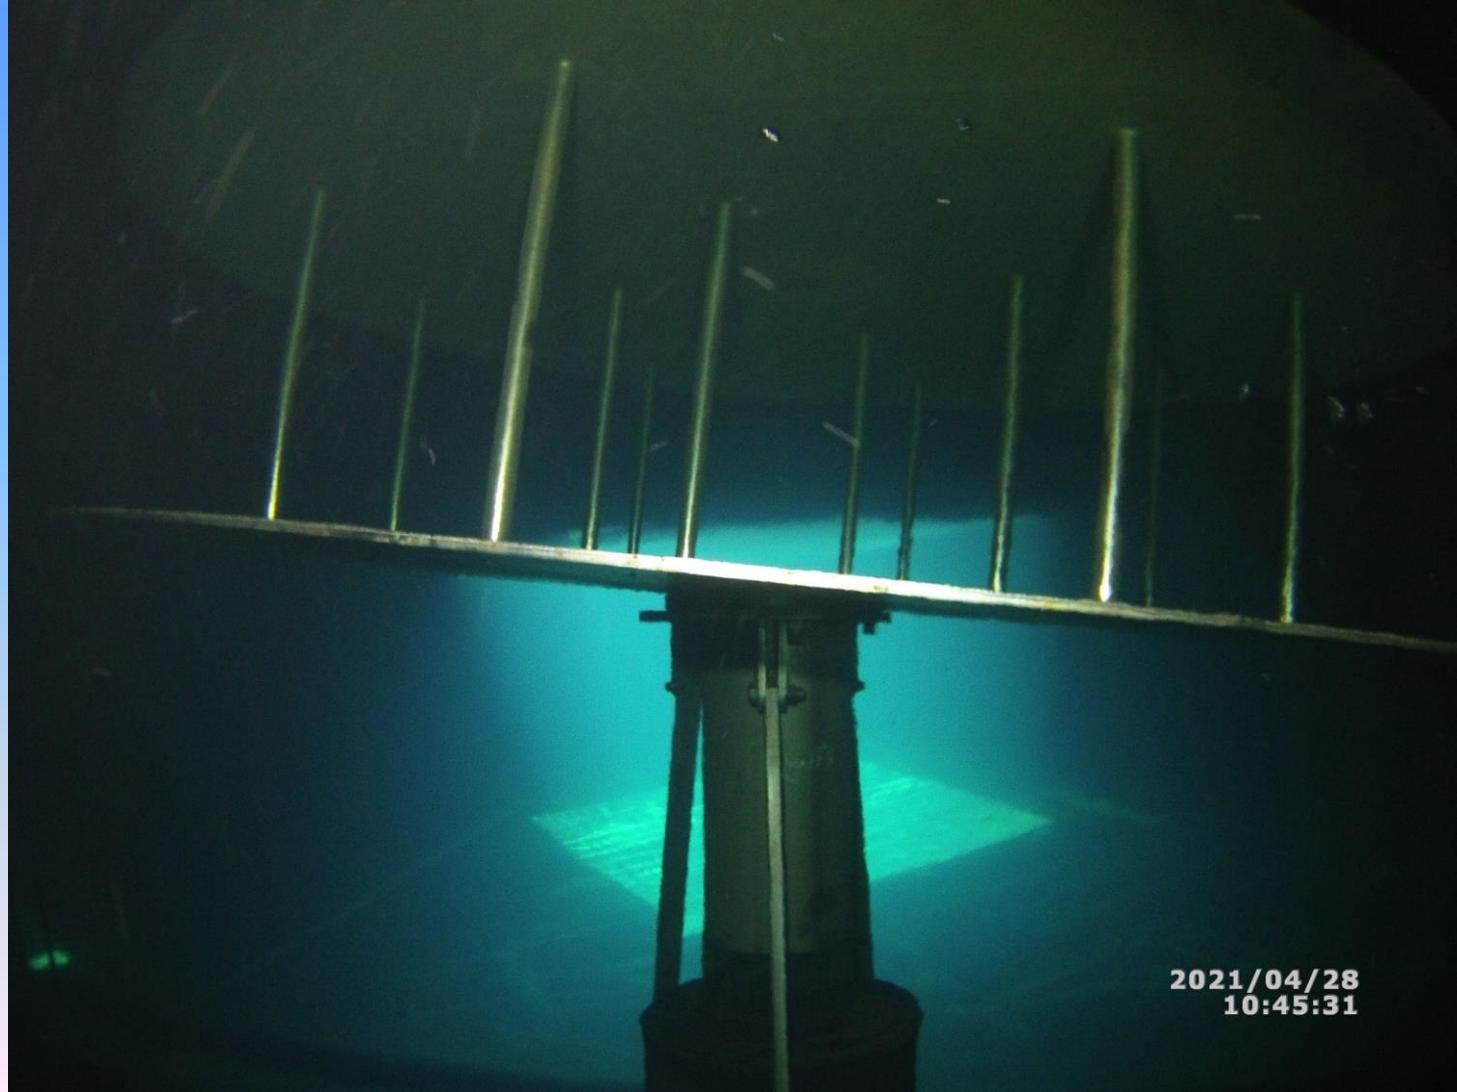
2021/04/28  
10:45:31

The weight pipes made sure  
the floating liner sunk deeper.

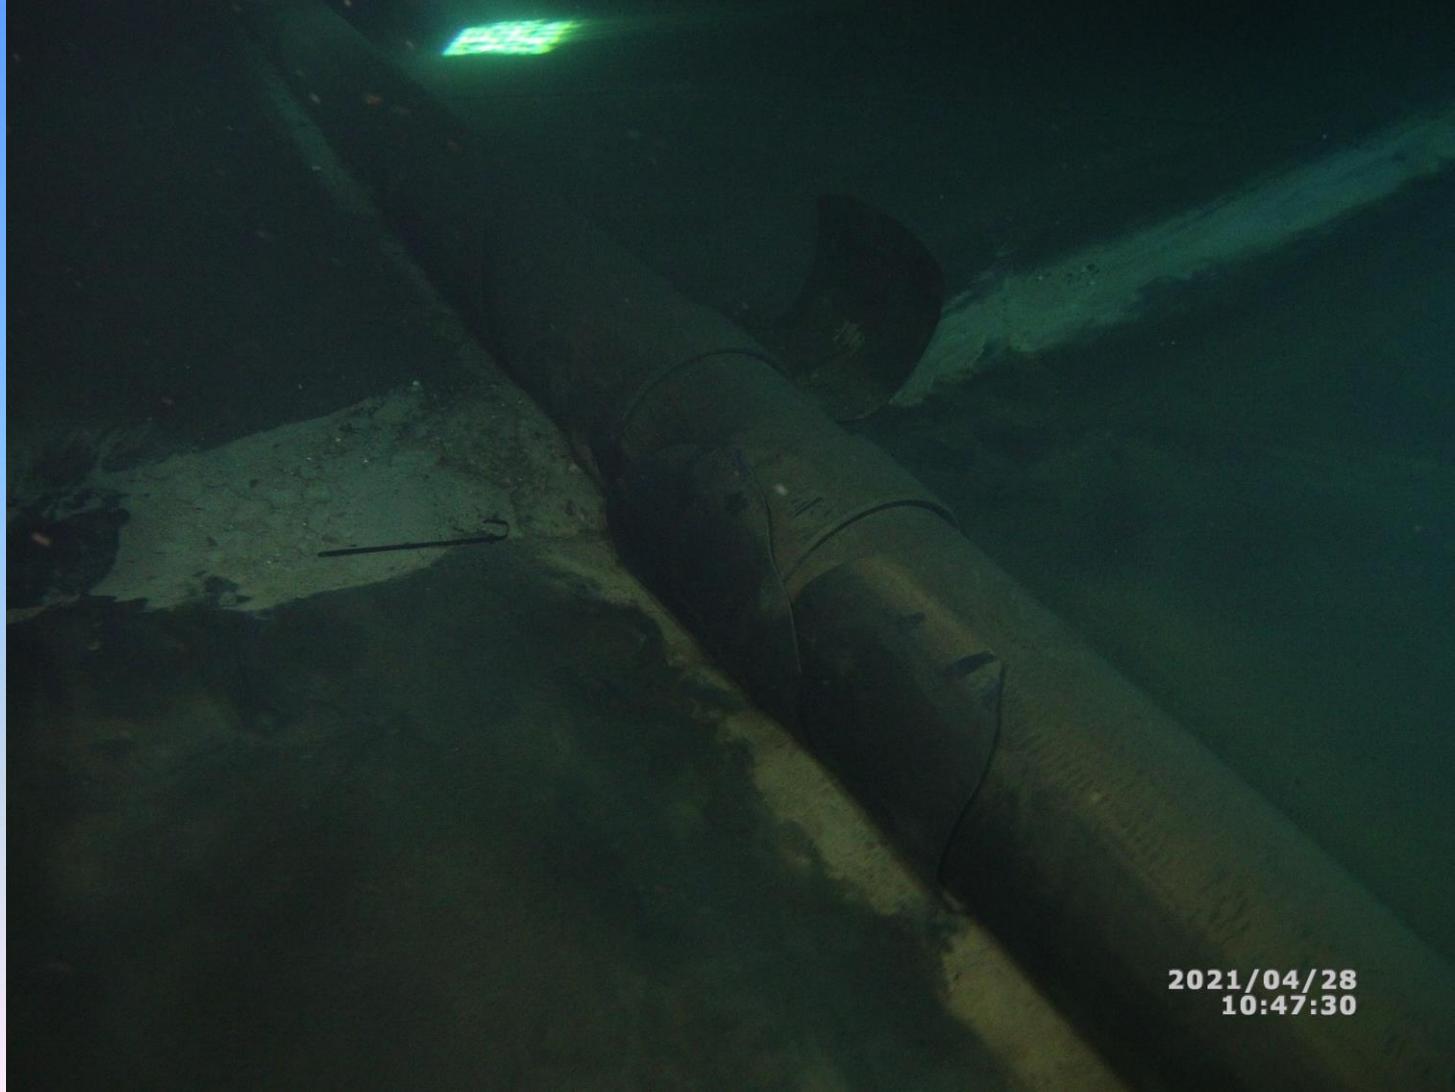
2021/04/28  
10:47:30

The weight pipes might fall to the bottom and penetrate bottom liner

We opened the corners in order to remove the weight pipes from the floating liner.
