Dronninglund Fjernvarme

Followup meeting #7 on Teams, 28.10.2020

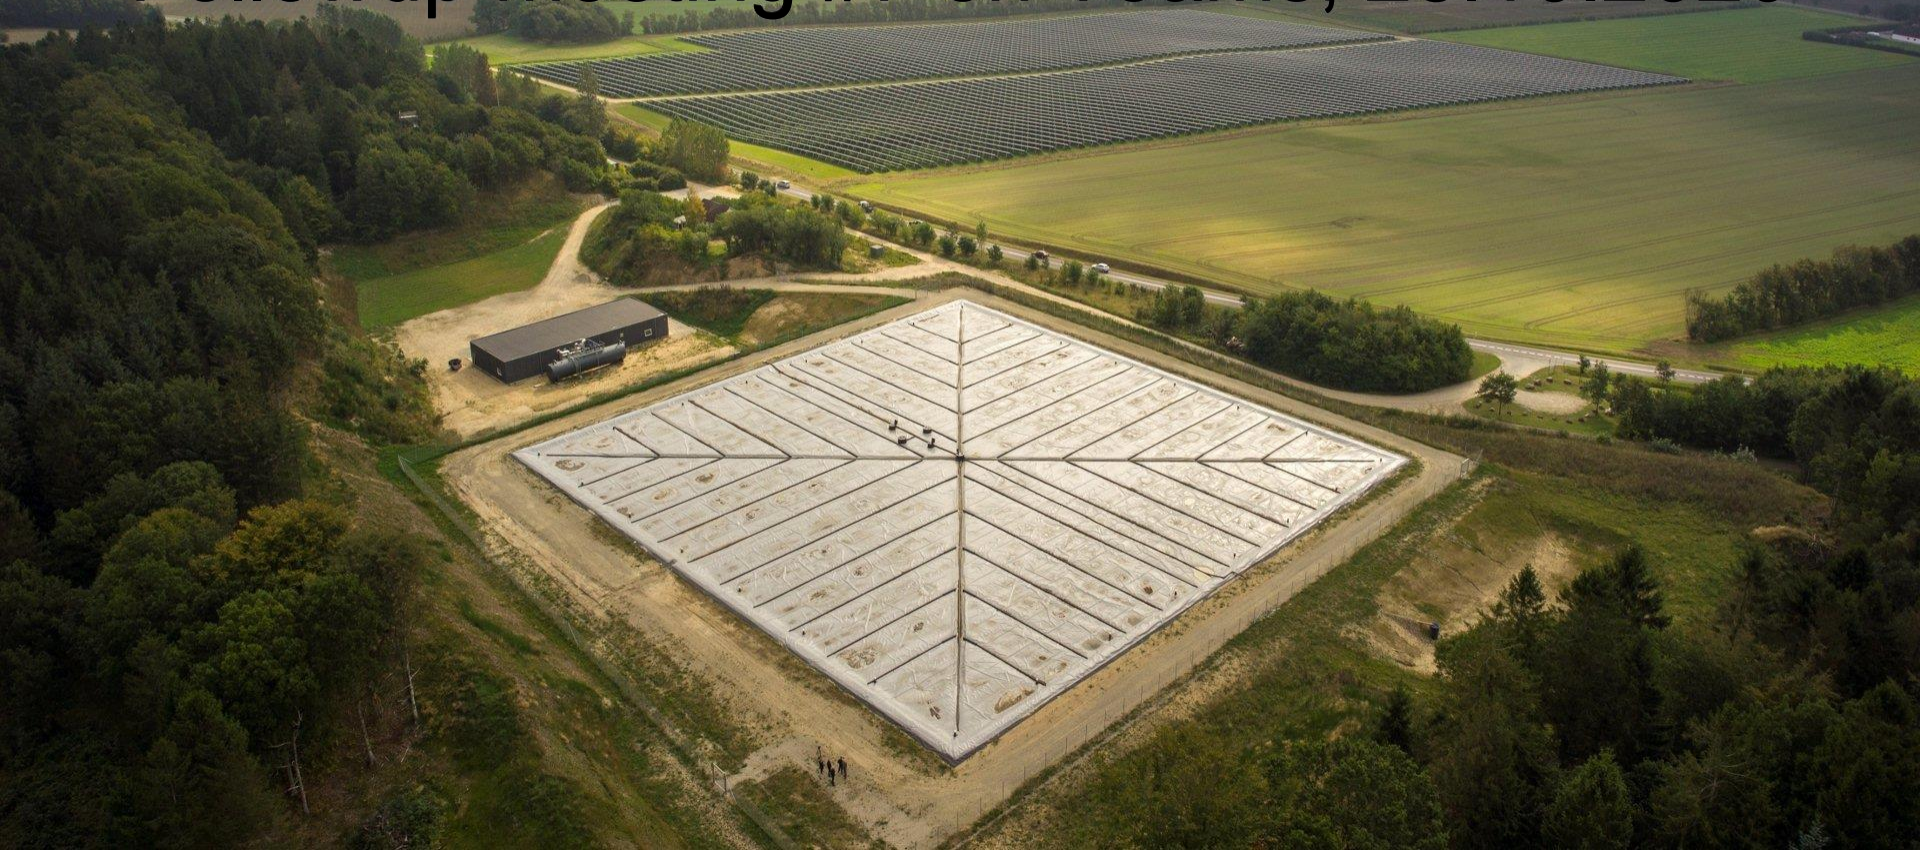
Drone picture from an altitude of 25 meters, taken spring of 2019.

You see many small lakes forming on the top liner.
On this picture we have started to empty the lakes in the South/ East corner

The daily maintenance consist mainly of pumping the water away from the lakes when they have grown to big.
Time consumption app. 2-3 hours a week year around.

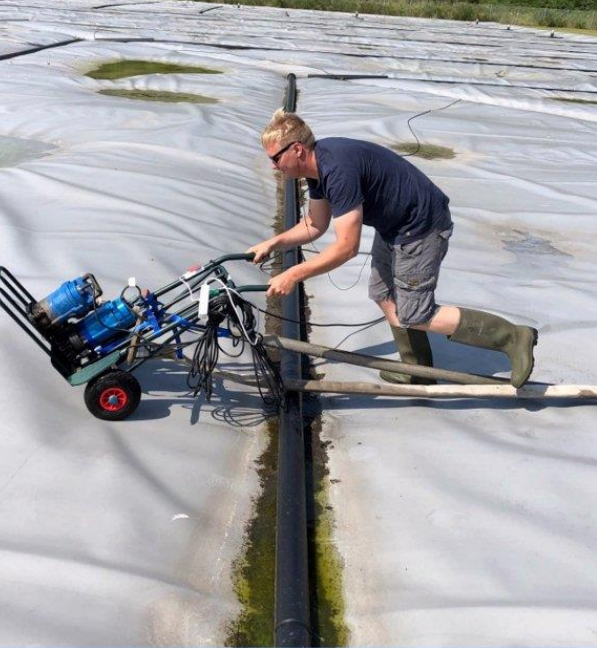
**Pumping water away
from the lakes**

**Patent
Dronninglund ☺**

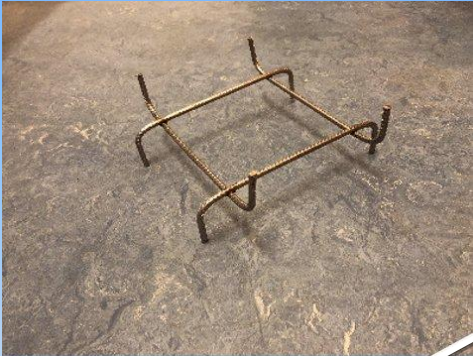
4. Net for air circulation.
5. Floating liner with weight tubes.

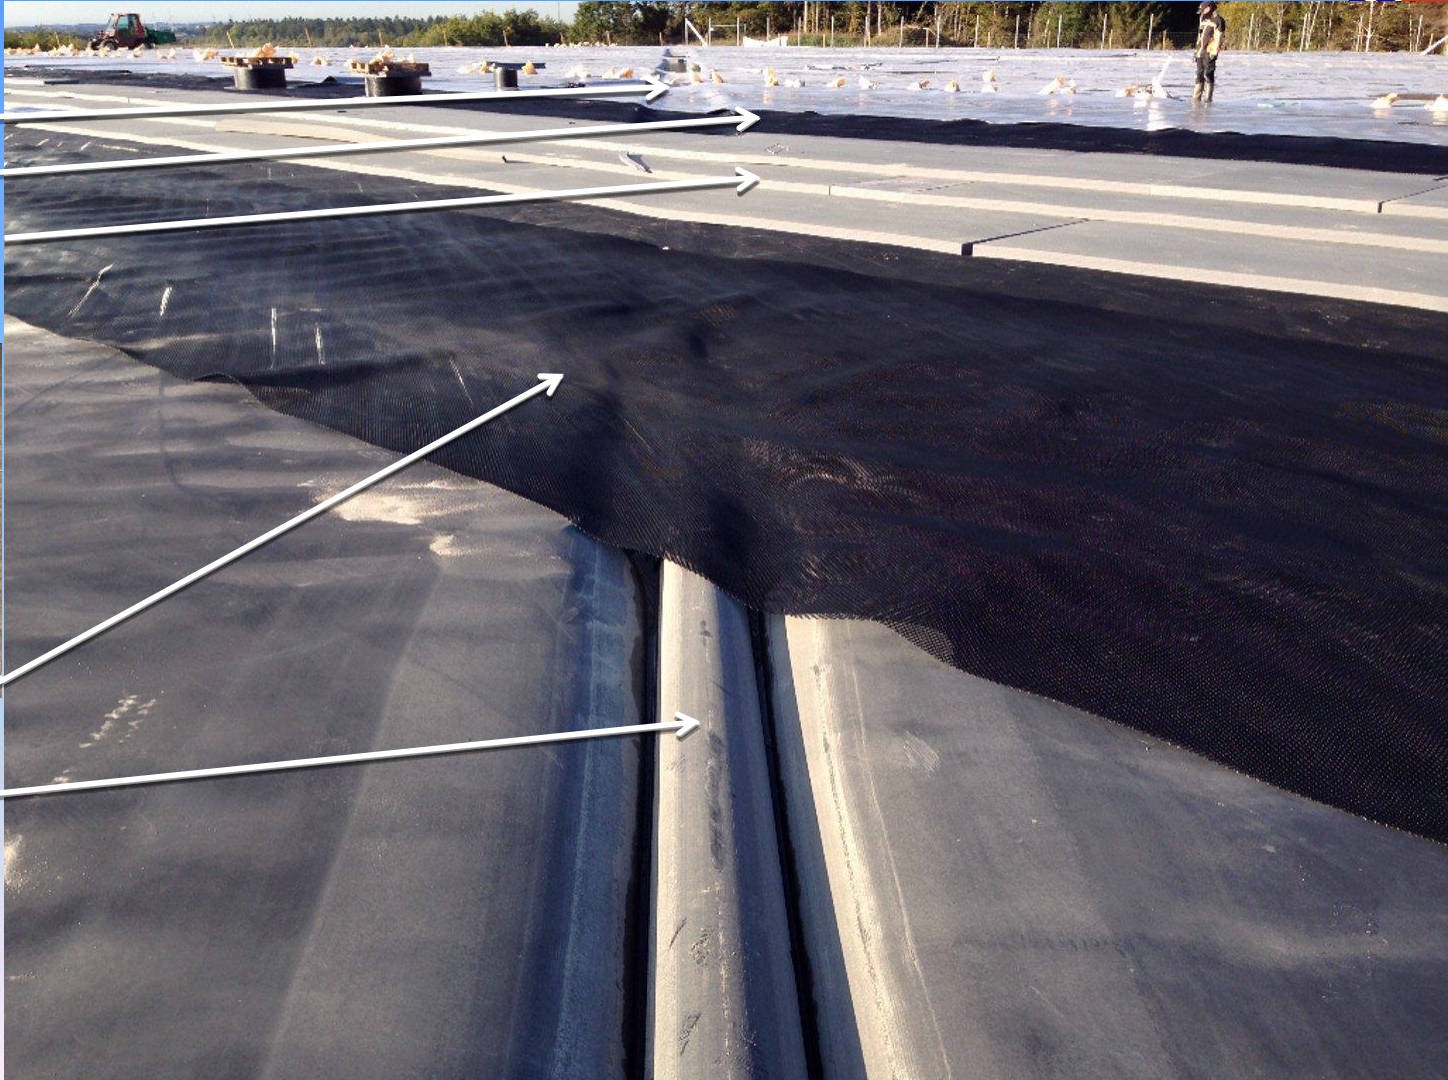
Some of the lakes started to get warm.

We opened the top liner to inspect the insulation and the floating liner.

We found hot water soaking the insulation. It was water from the tank, leaking through a hole in the floating liner.

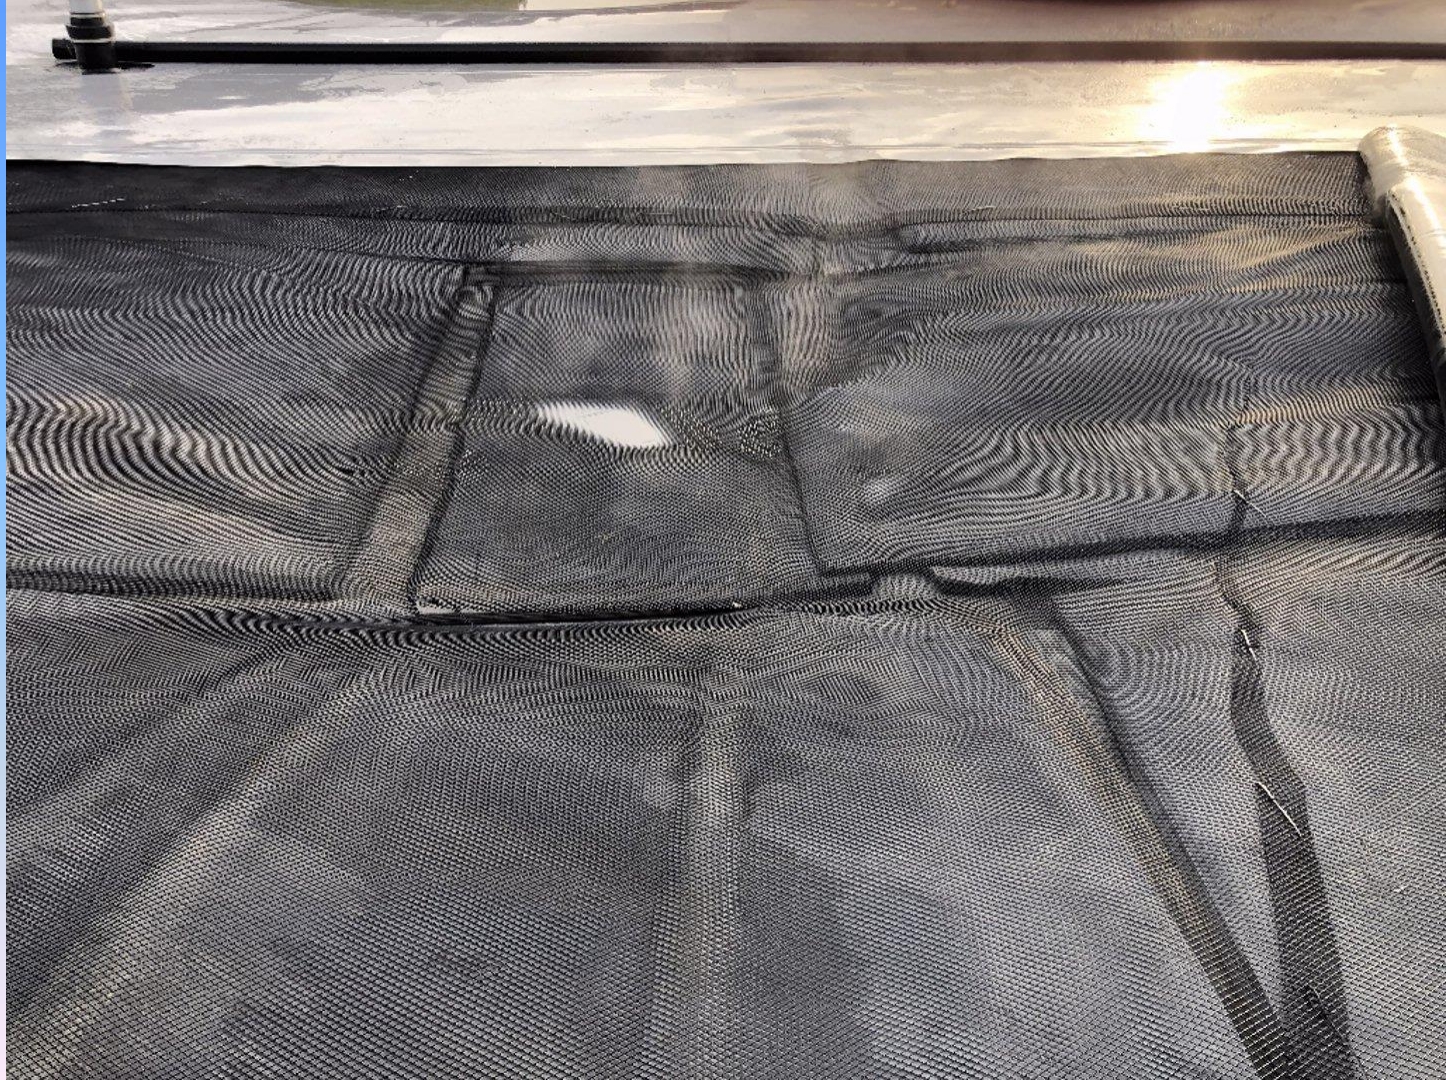
As a combination of the weight from the lakes and the hot water, the insulation was deformed.
Some of it was reduced to $\frac{1}{4}$ of the original thickness.

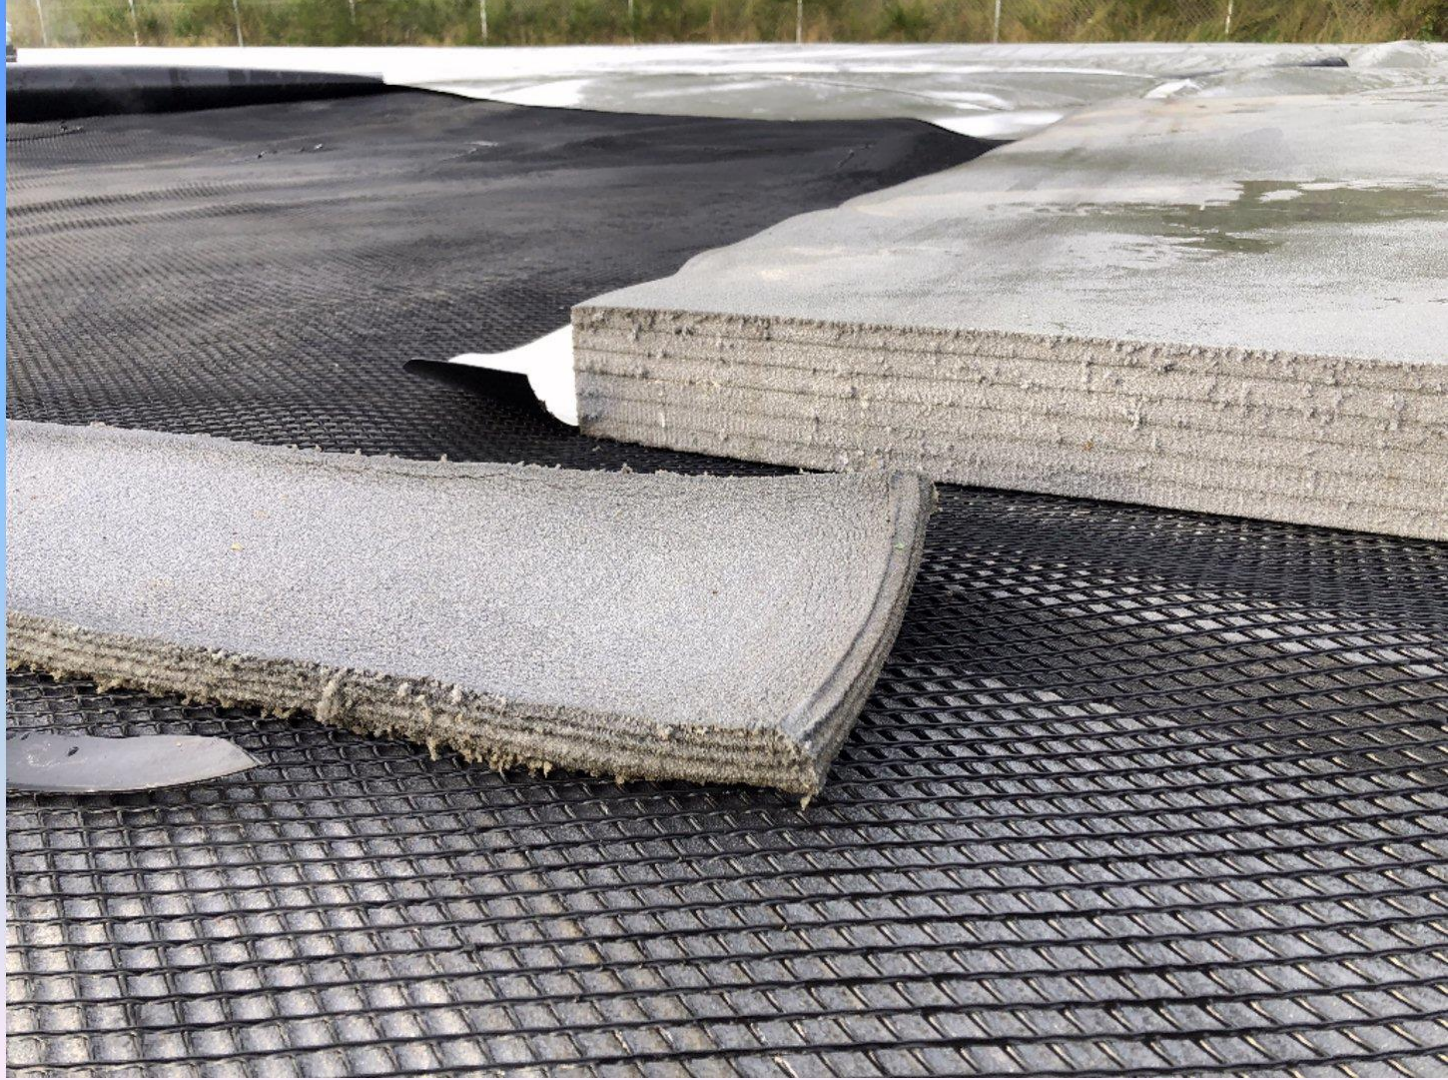
The insulation is so thin in some places, that the spikes from the fixation irons between the two lower layers is a threat to the floating liner.

That's why we begin to have holes in our floating liner.

- Continue to empty the lakes that keeps forming on the lid.
- On a regular basis we will find the lakes that start to get to hot, open the topline and inspect the insulation and topline.
 - If we find a hole we will repair it.
 - If the insulation is to thin we will replace it.
 - We will remove any fixation iron we find.

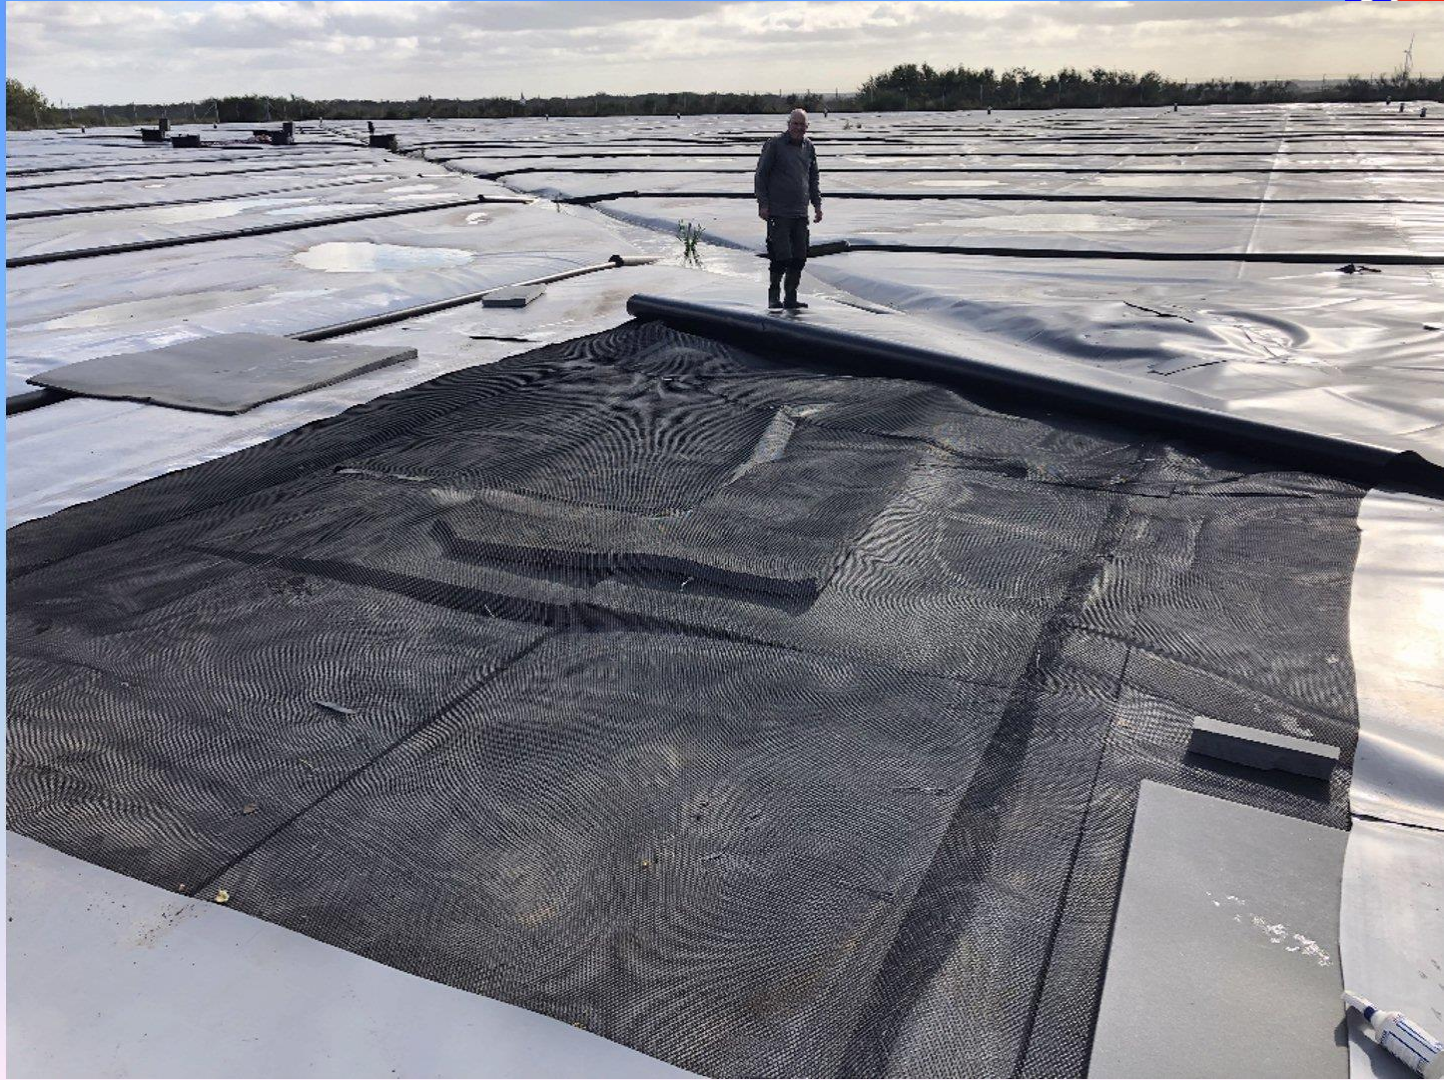
**Drone infrared picture from an altitude of 25 meters.
Taken spring of 2019.**

We see that:

Pumping the water away from the lakes does reduce the loss of heat.

There is a considerable loss of heat from the side of the pit storage.

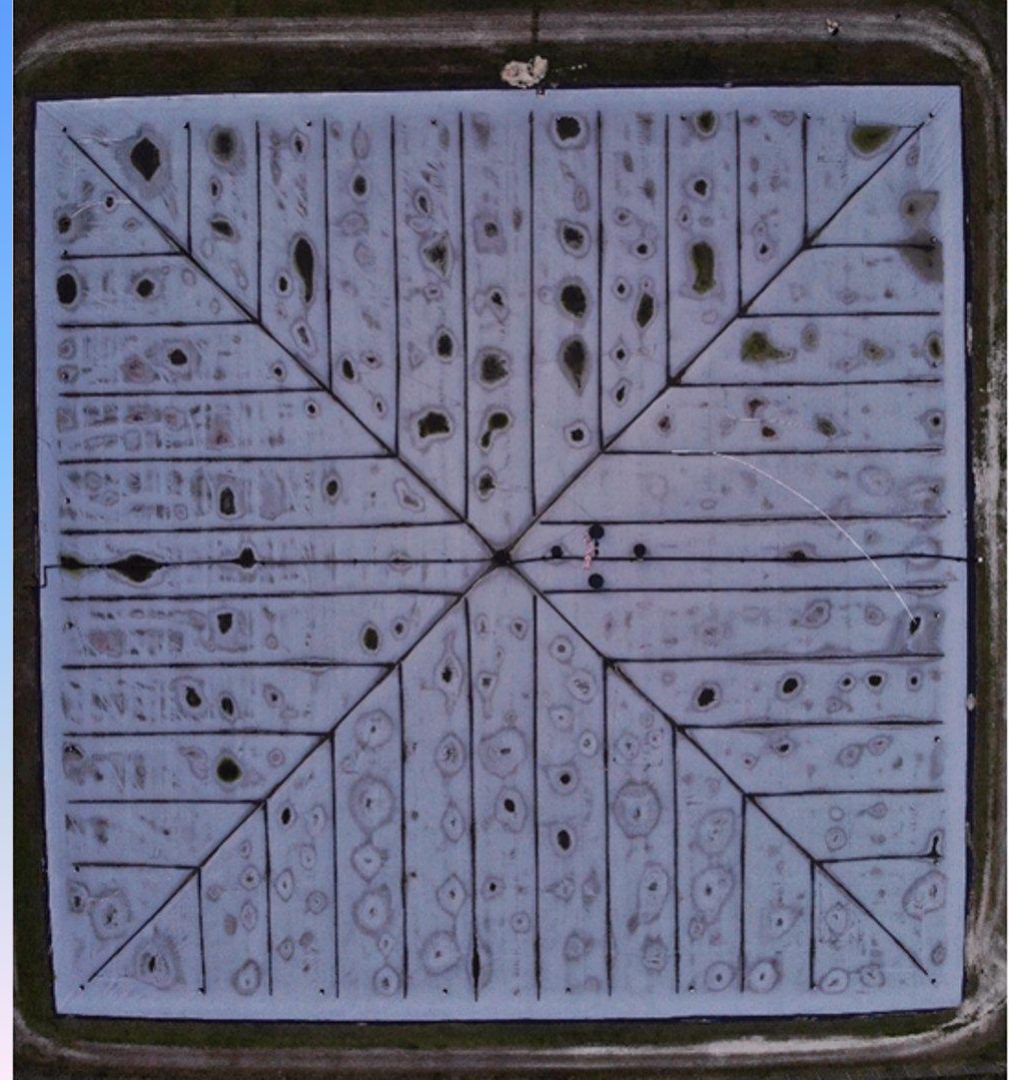
How to find the hot lakes?

An easy way is to inspect the lid in the early morning of a cold day. Steam will rise from the hot lake.

We will also use an infrared camera.
