Damvarmelager Høje-Taastrup

Status 2021

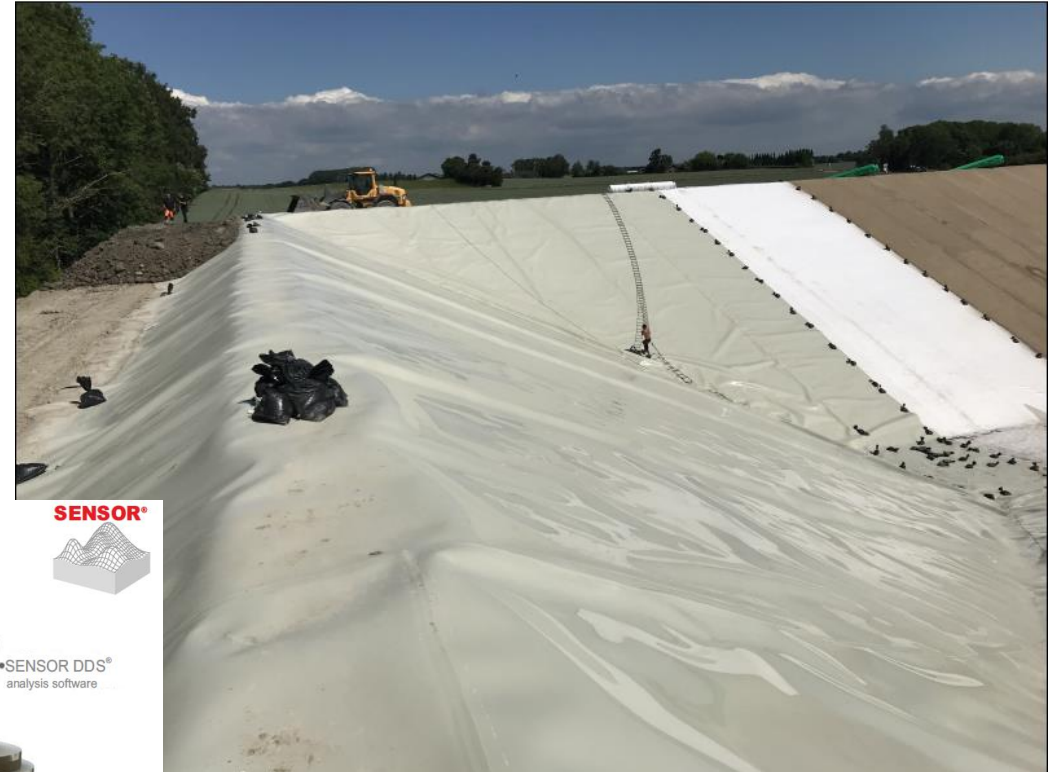
Liner

- New type PP-liner
- Lifetime 33 years at 95 celcius
- Subcontractor/-Supplier: AGRU og Gquadrat
