# Dronninglund Fjernvarme

Followup meeting #8 i Aalborg, 27.10.2021

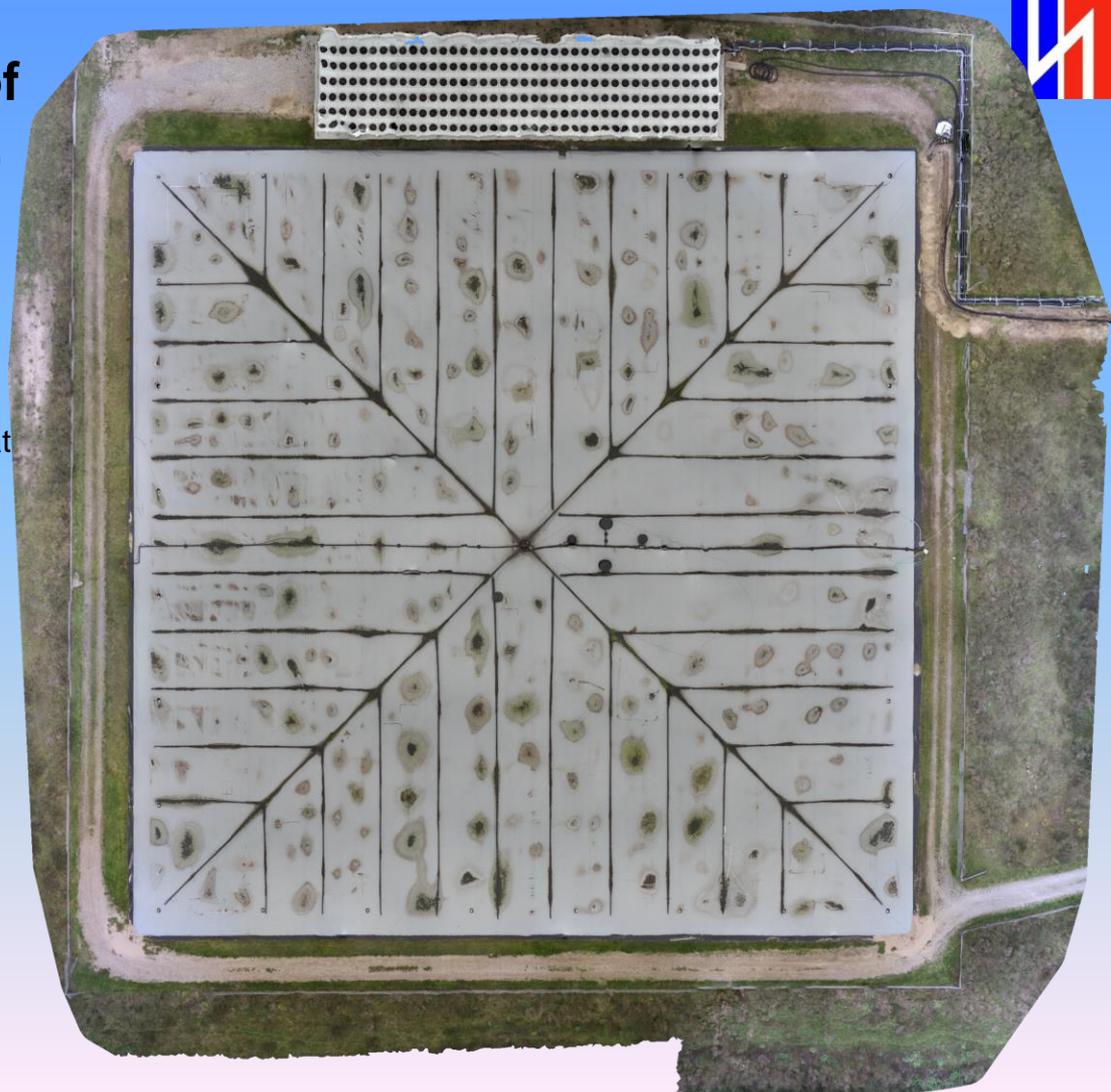
# Drone picture from an altitude of 25 meters, taken spring of 2020.

You see many small lakes forming on the top liner.  
On this picture we have started to empty the lakes in the South/ East corner

The daily maintenance consist mainly of pumping the water away from the lakes when they have grown to big.  
Time consumption app. 2-3 hours a week year around.

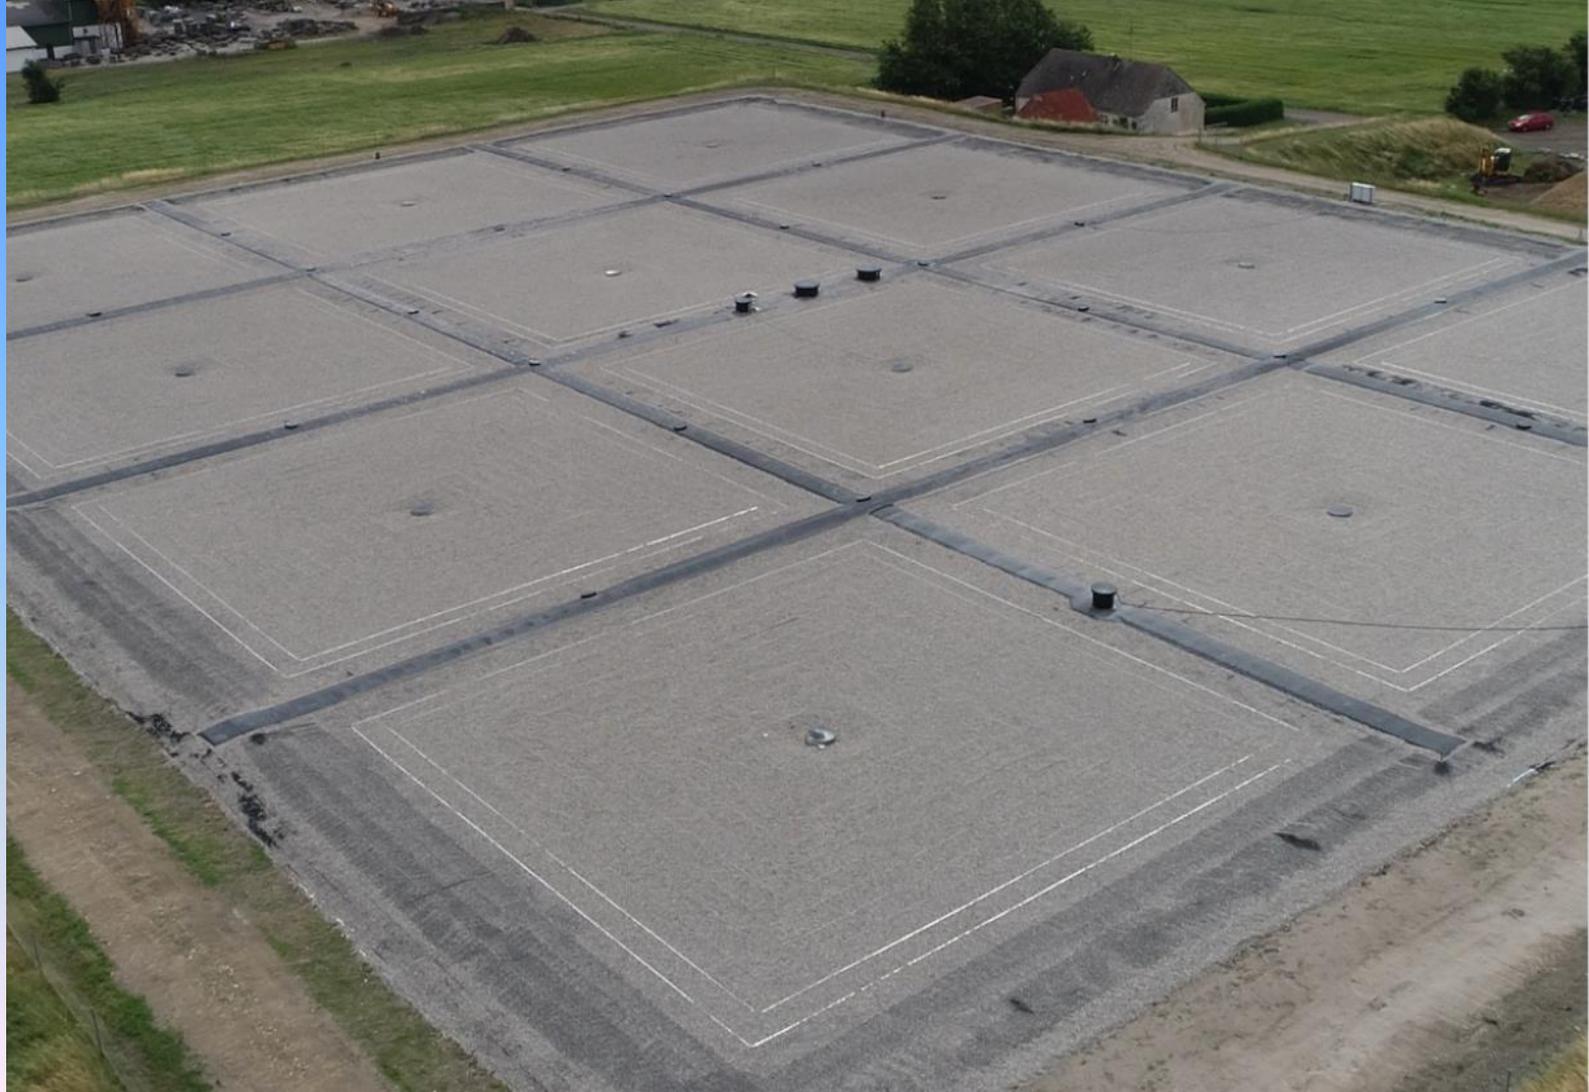
The lid was dismantled.

Some of the insulation was kept for re-use.

**Now we are  
waiting for  
Allborg CSP  
to buildt a  
new lid.**
